# Establishing Natives on Sand Dunes

Case Study - Caroline Bay, Timaru

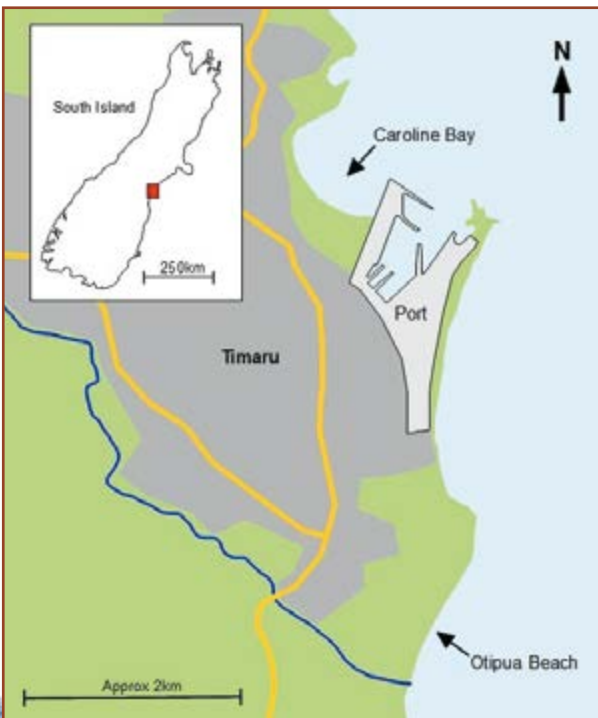
*Caroline Bay is an artificial beach and dune system created by the shelter provided by the Timaru Harbour. A groyne that provides safe passage of ships into the port prevents the northward drift of gravels to build on the south side but allows the finer sands to bypass the port entrance and become deposited in the bay immediately to the north.*

Outside the harbour, high-energy southerly waves drive drifts of foreshore gravels and nearshore sands northward. The eastern breakwater acts as a barrier to the drift of foreshore gravels, causing coarse sediments to accumulate south of the port but nearshore shelf sands are swept past the port and into the entrance of Caroline Bay.

Before harbour works began in the 19th century, Caroline bay was moderately deep, with a narrow mixed sand and gravel beach and a rocky sea floor. Since construction of the port of Timaru started in 1878, approximately 3,000 m<sup>3</sup> of sand has accumulated annually in the shelter of Caroline Bay causing the shoreline to advanced seaward by more than 650 m.

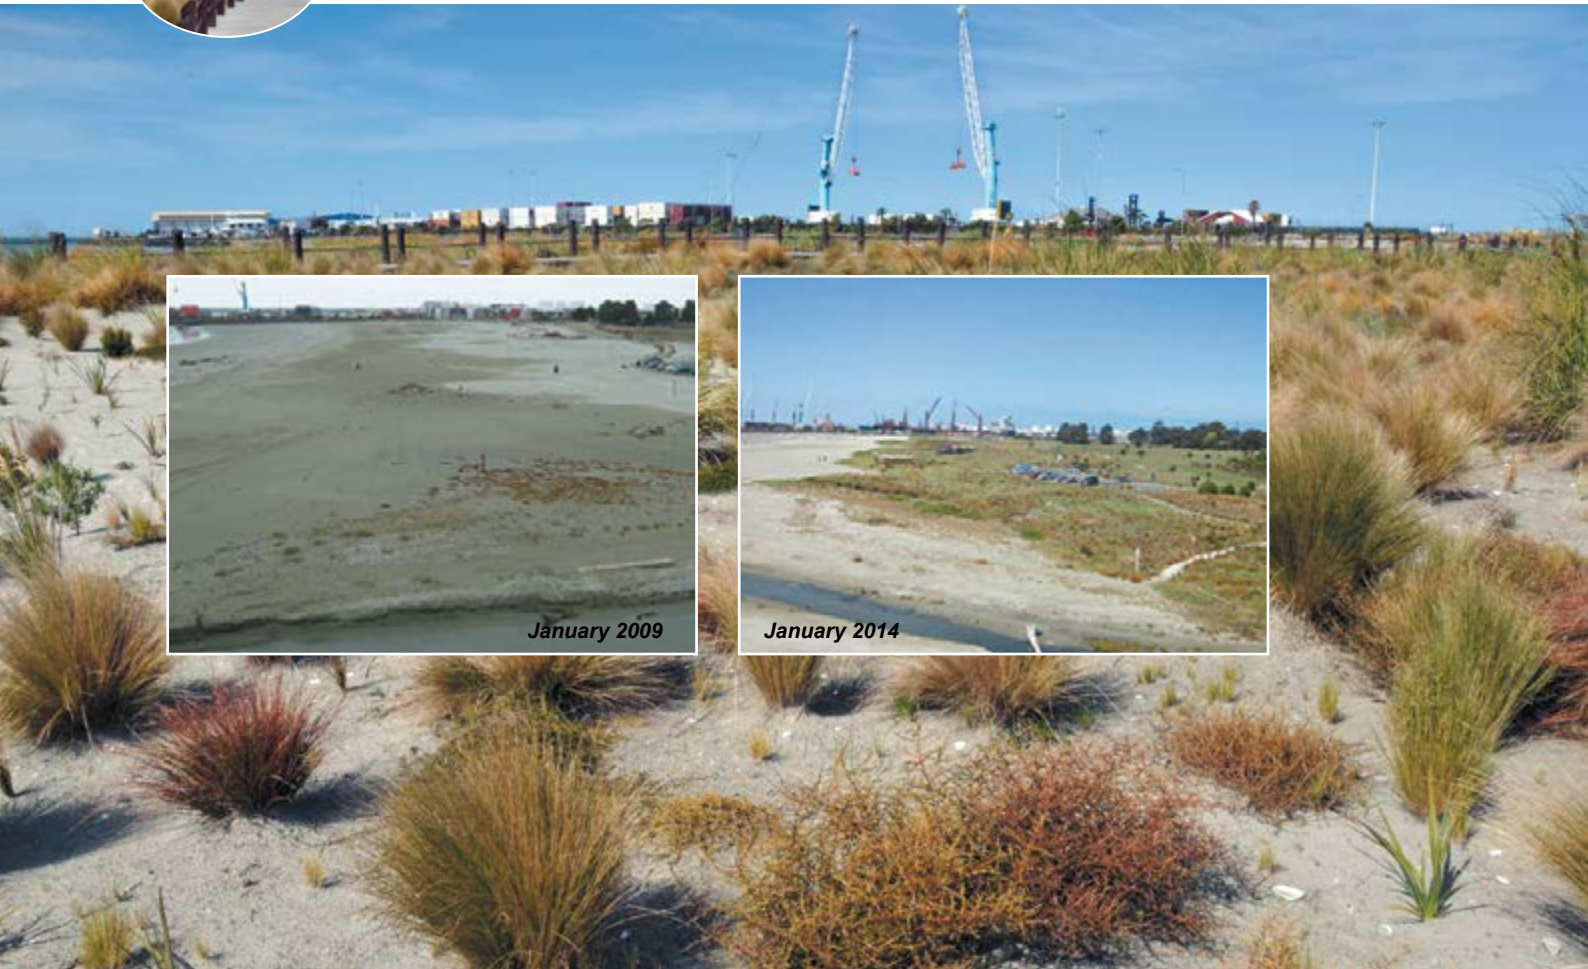
*The rapid change in vegetation cover along the dunes of Caroline Bay since the restoration programme was initiated. Note the lack of any vegetation seaward of the carpark (left) and the establishment of a 30 m wide dense cover of natives on foredunes seaward of the same carpark five years later (right). Providing formal accessways has been an important component of the dune restoration programme to protect dune vegetation.*

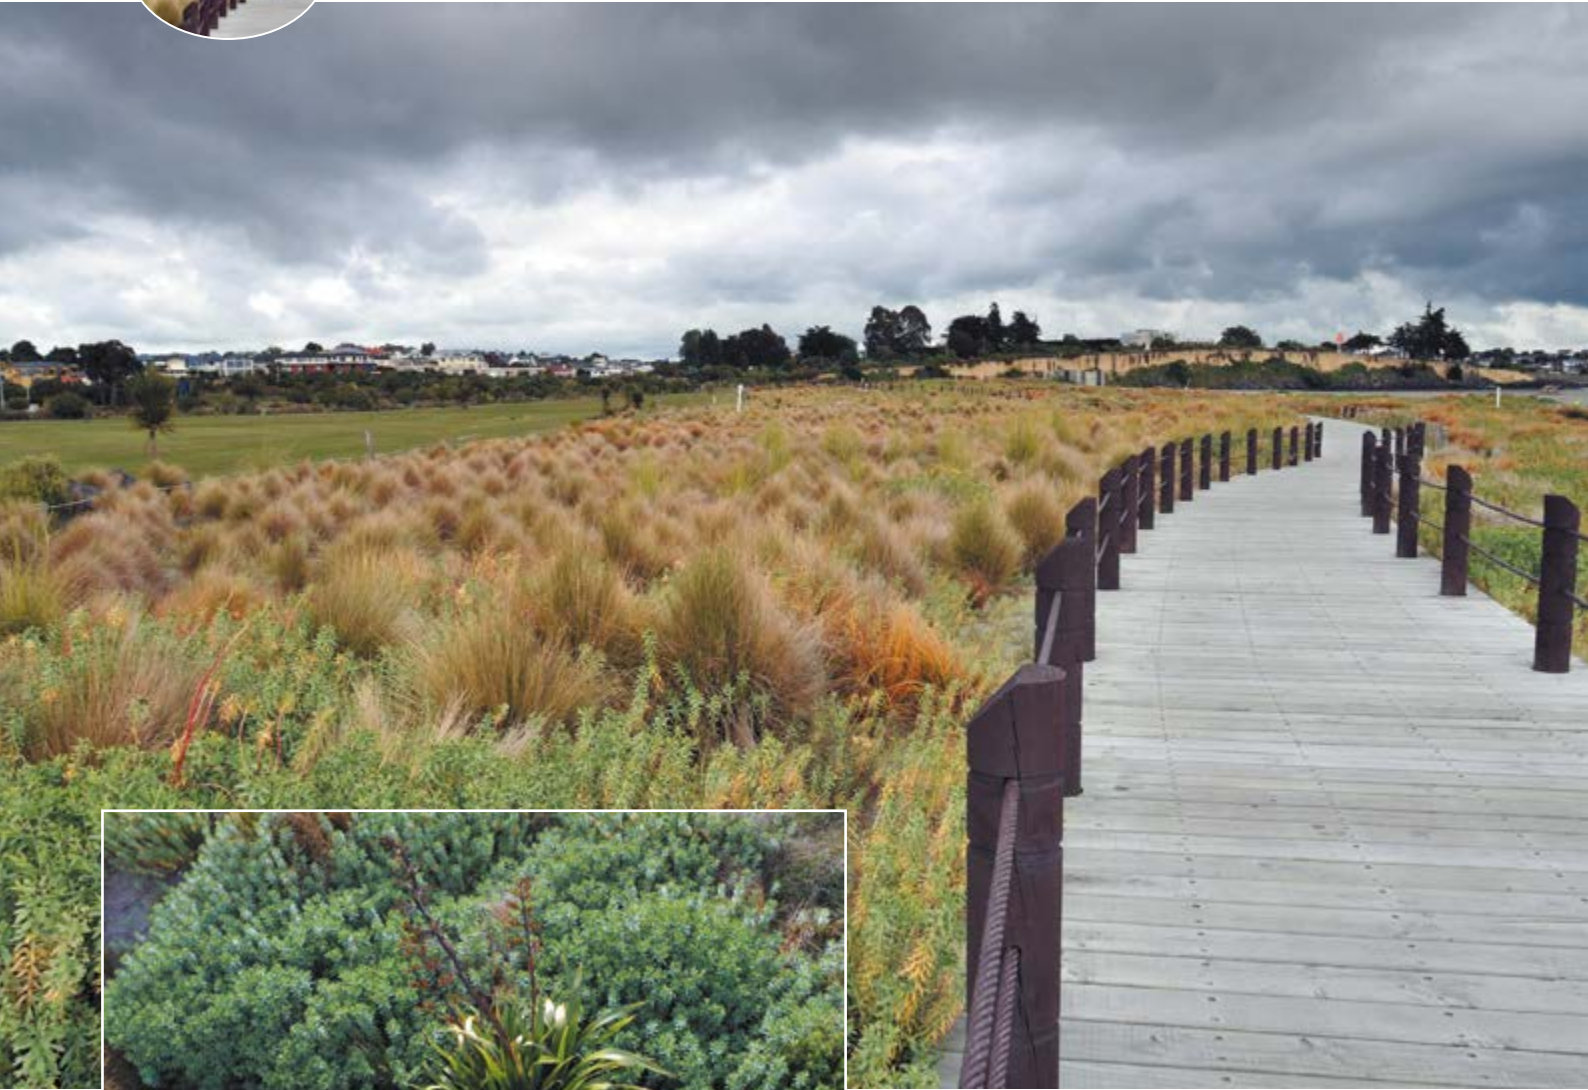
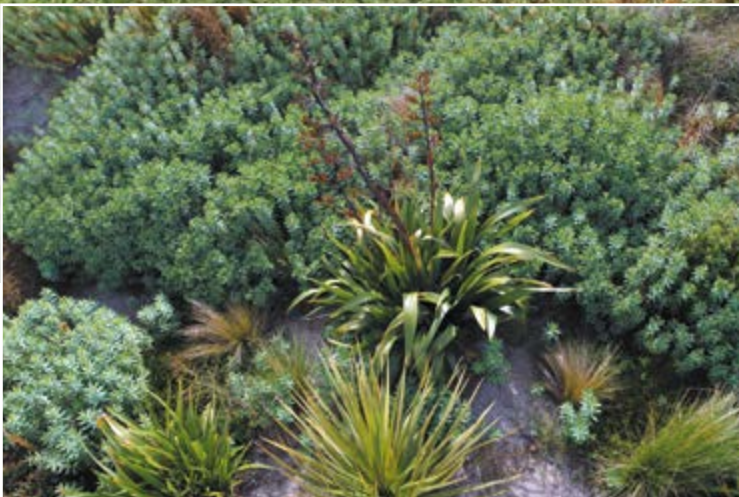
*A diverse mixture of backdune species at Caroline Bay established and managed by the Timaru District Council provides one of the best examples of backdune restoration in the country. Boardwalks and viewing platforms allow beach users easy access to this popular bay while protecting the vegetation cover.*

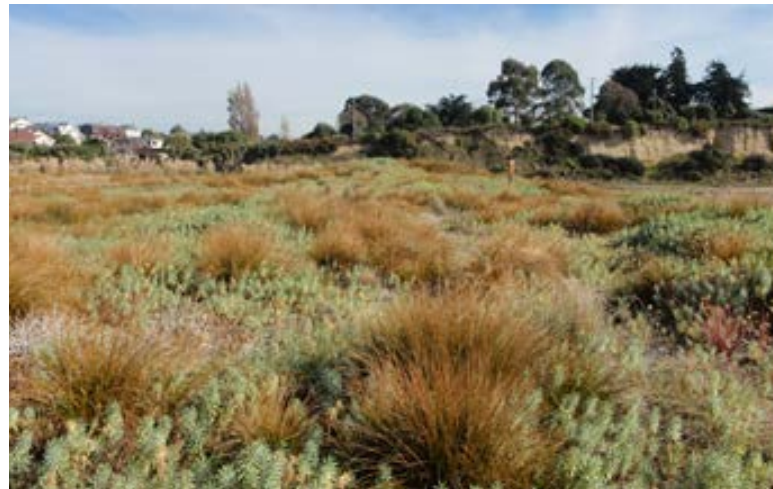
Planted native shore spurge and wiwi quickly dominate semi-stable backdunes providing a low dense cover, Caroline Bay, Timaru.

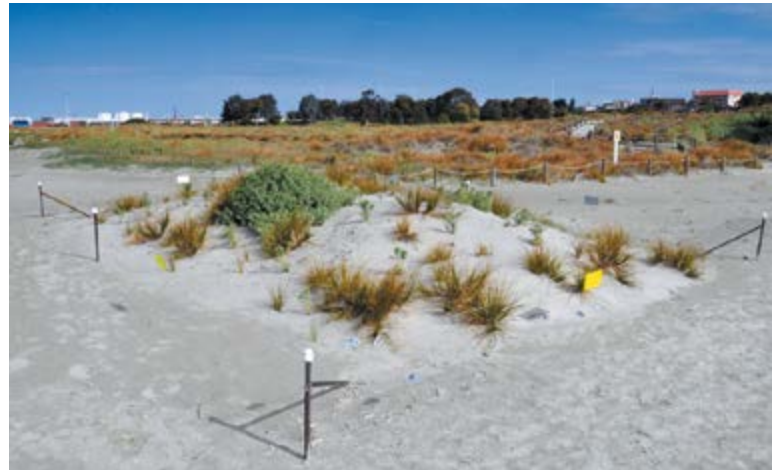
*Natural regeneration of sand carex has dominated the toe of foredunes replacing planted spinifex and forming low dunes along the strandline.*

A feature has been the naturally regeneration of dense colonies of sand carex along substantial areas of foredunes forming low dunes along the high water mark. Extensive colonies have formed as pure species stands but the species has also become a major component of landward dune zones amongst other species including shore spurge and wiwi.

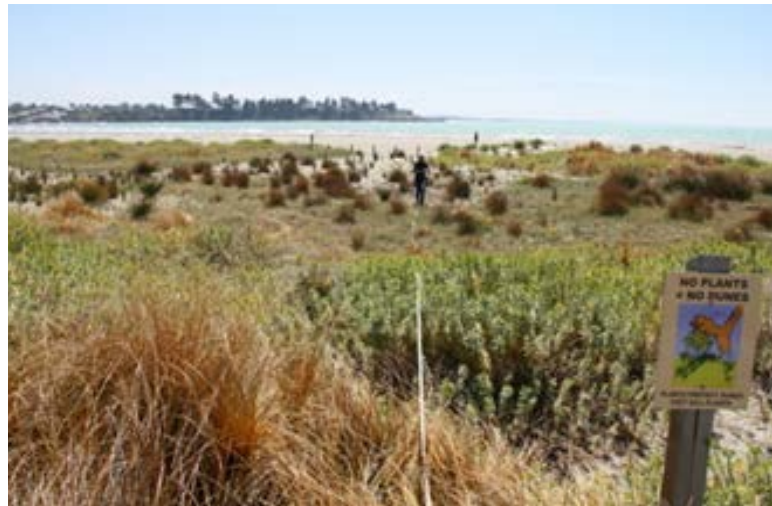
*Temporary fencing to protect seaward planted and regenerating pingao and shore spurge near a main accessway. Note the build up of a small dune.*

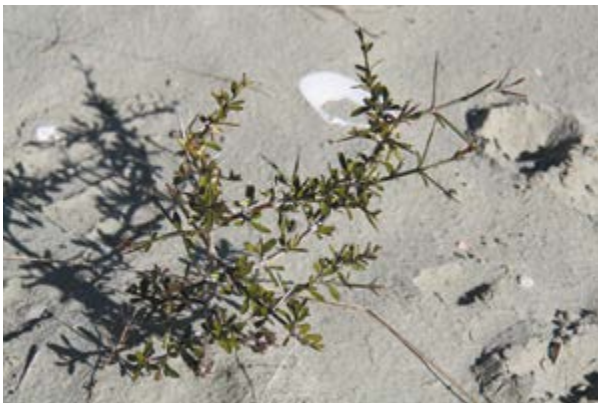
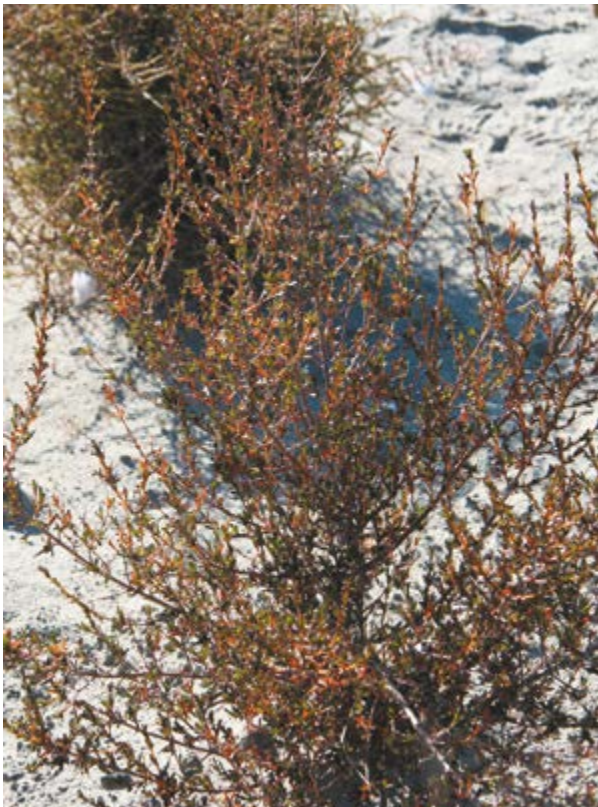
A range of species are inter-planted in gaps amongst established planted backdunes such as matagouri (above) and *Coprosma propinqua* (below).

A feature has been the interplanting of less commonly planted species within back dune areas amongst the well-established mixed species of pohuehue, sand carex, sand tussock and sand daphne including mountain akeake, broadleaf, korokio, matagouri, *Coprosma propinqua*, rauhuia or NZ true flax (*Linum monogynum*) and kokomuka or shore koromiko (*Hebe elliptica*).

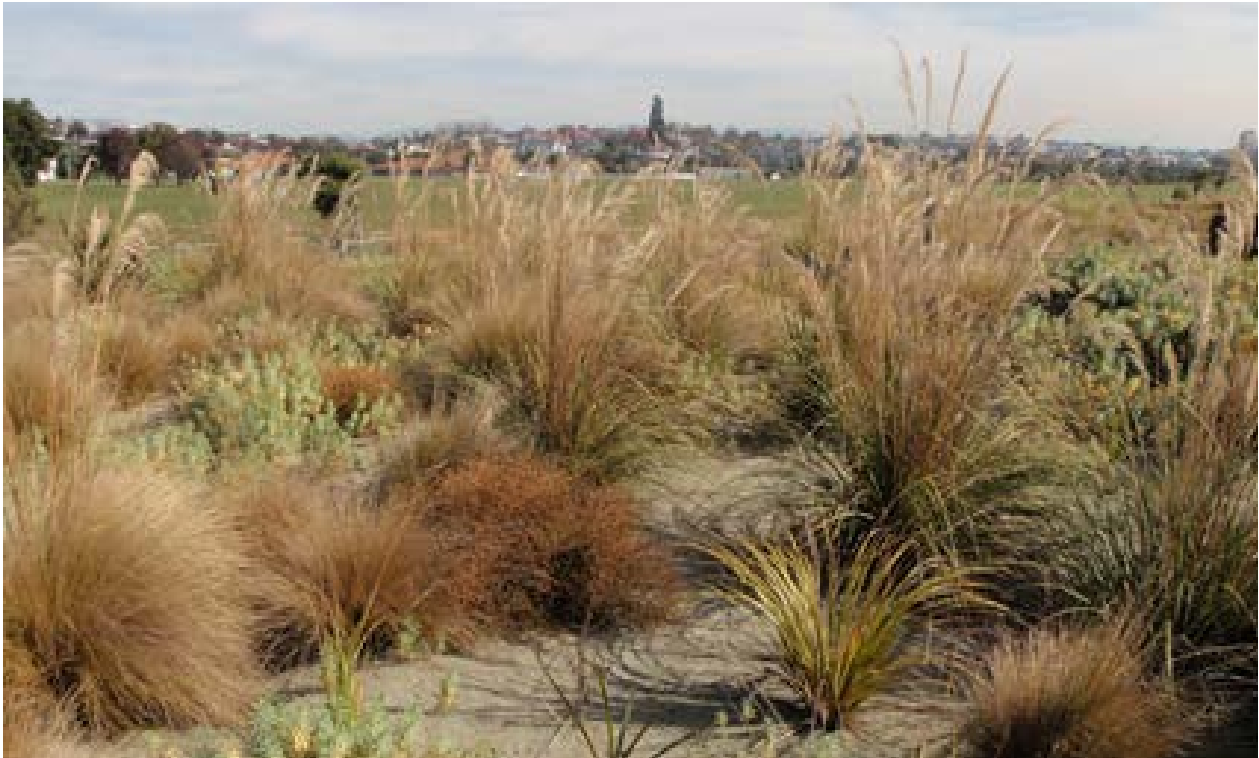
A wide range of backdune natives established within the last 3 years at Caroline Bay, Timaru. Excellent maintenance, particularly weed control, has seen very high survival and growth of planted natives including toetoe, sand coprosma, sand daphne, pohuehue, harakeke, ti kouka and Carex species.

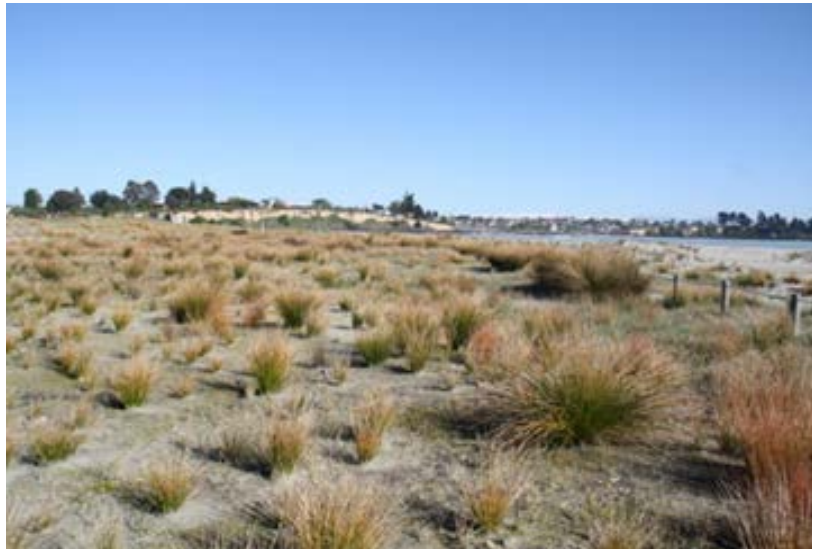
*A large backdune area dominated by wivi planted over the last 3 years with new natural regeneration across the rest of the site at Caroline Bay, Timaru.*

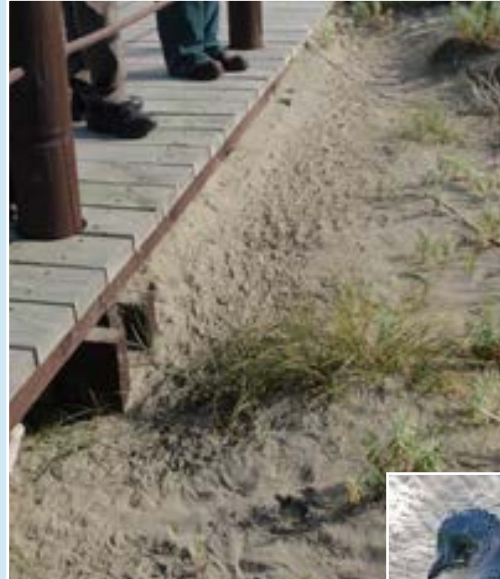
*Tracks along the edge of board walks indicate blue penguin have recently begun to utilize parts of the restored backdunes at Caroline Bay, Timaru.*

Since the backdunes have been revegetated in a cover of native plants blue penguins have begun to appear in the dunes. In particular the crawl space under the new boardwalks have proved to be a popular site for overnight roosting of penguins.
